# Release Notes

## Initial Firmware (H\_5229\_PTZ) for SN673V-C Cameras

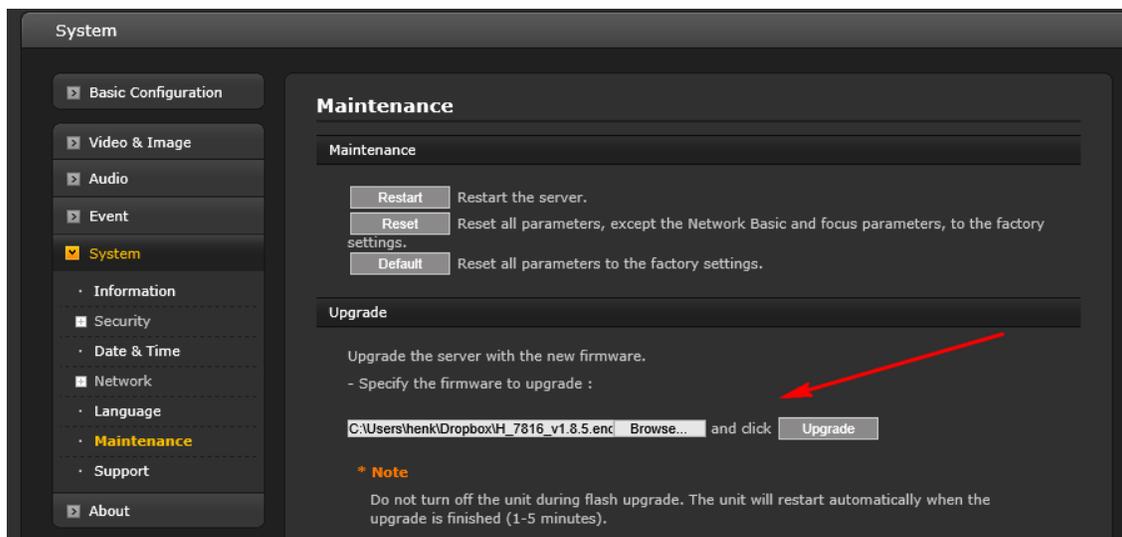
Download the firmware to your PC. Go to the camera’s Maintenance screen:

Open the Upgrade section and use the Browse button to locate the firmware on your PC. Press the upgrade button. During the upgrade process, do not turn off power to the camera. Wait at least 5 minutes and access the camera again.

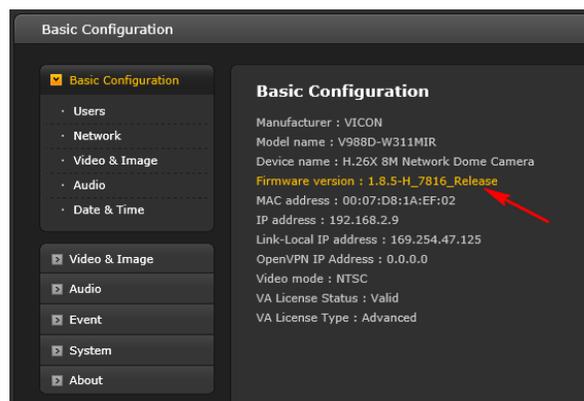
Once complete, the firmware version can be checked from the Basic Configuration screen.
