Release Notes

November 2021

Firmware Update for Camera Model V2360W-12 Panoramic

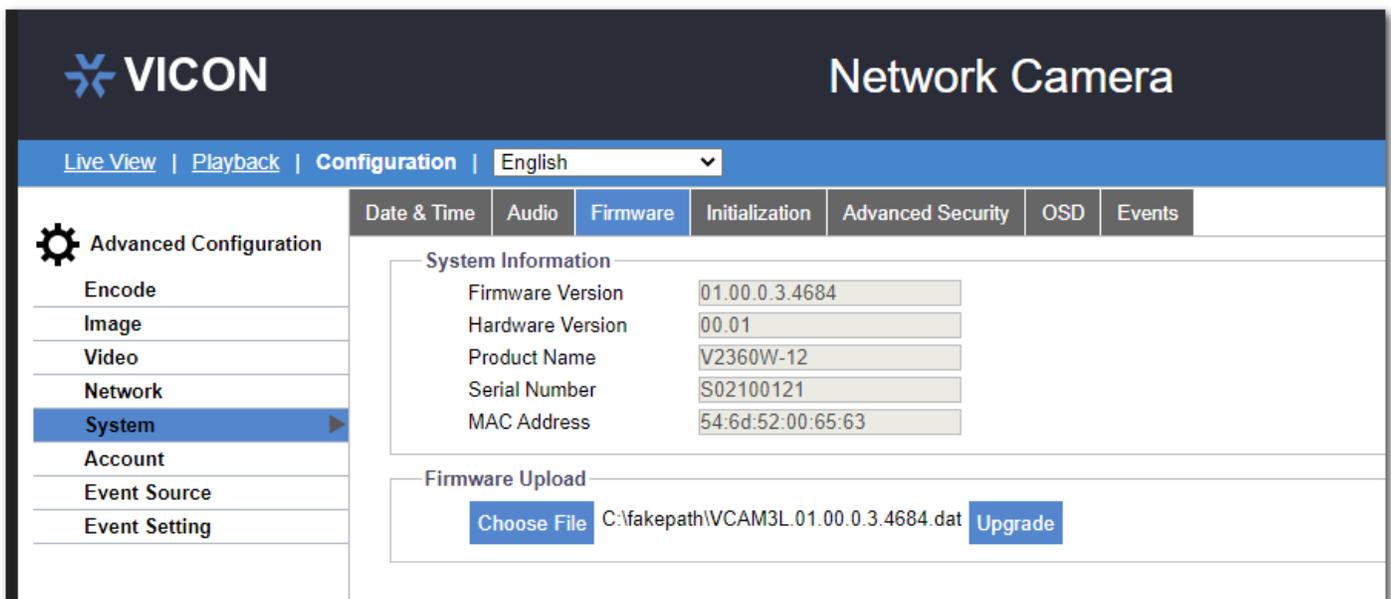
In the camera web interface, under Configuration > System > Firmware, press “Choose File” and select the downloaded firmware file. Then press “Upgrade” to start the update. The camera will install the update and reboot with the new firmware version:

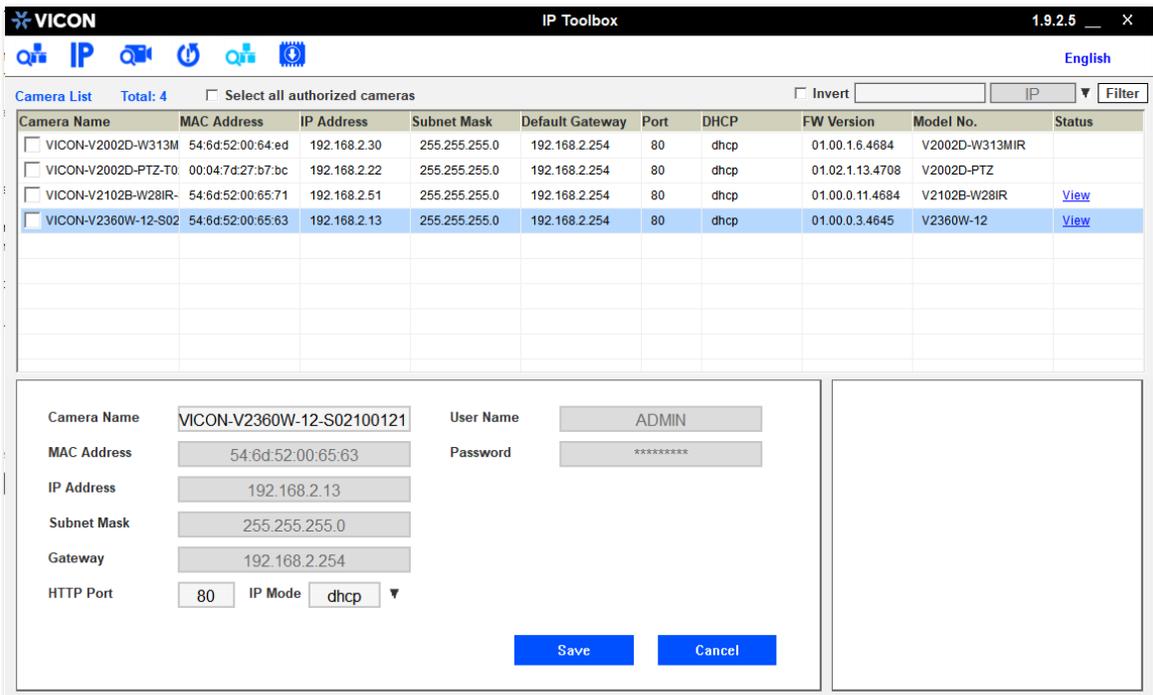
Download and install the IP Toolbox utility from the Vicon webpage:

Scan the network to discover the applicable cameras on the local network. Press the firmware update button, select the downloaded firmware and fill in the camera credentials. Press the "+" button, and the list of cameras will appear that are suitable for the selected firmware. (Note that the cameras must have the same credentials, if more than one camera is updated.)

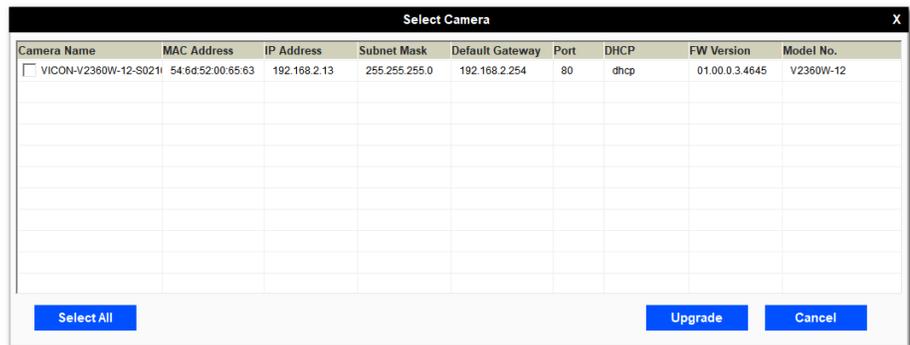
Select the cameras to be updated or just press "Select All" to update all cameras. Now press "Update." The camera will install the update and reboot with the new firmware version.
