SN663V-B, SN673V-B, SN680D-B-WINR, V921B, V922B, V922D, V932EZ and V-CELL-HD-A Camera Firmware

General Description

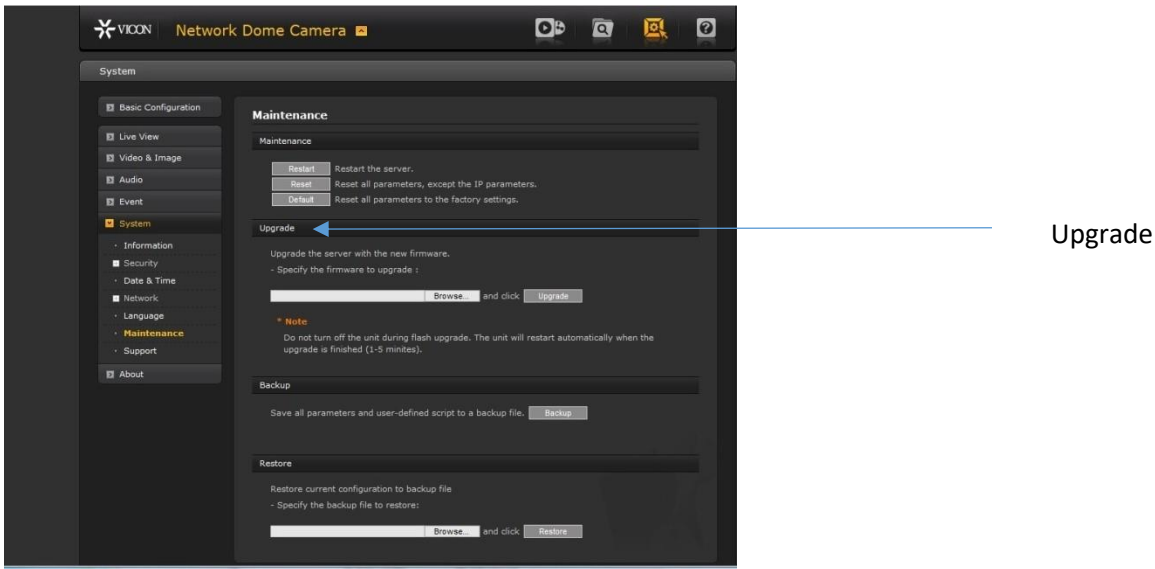
Download the firmware to your PC. Go to the camera's Maintenance screen.

Open the Upgrade section and use the Browse button to locate the firmware on your PC. Press the upgrade button. During the upgrade process, do not turn off power to the camera. Wait at least 5 minutes and access the camera again.

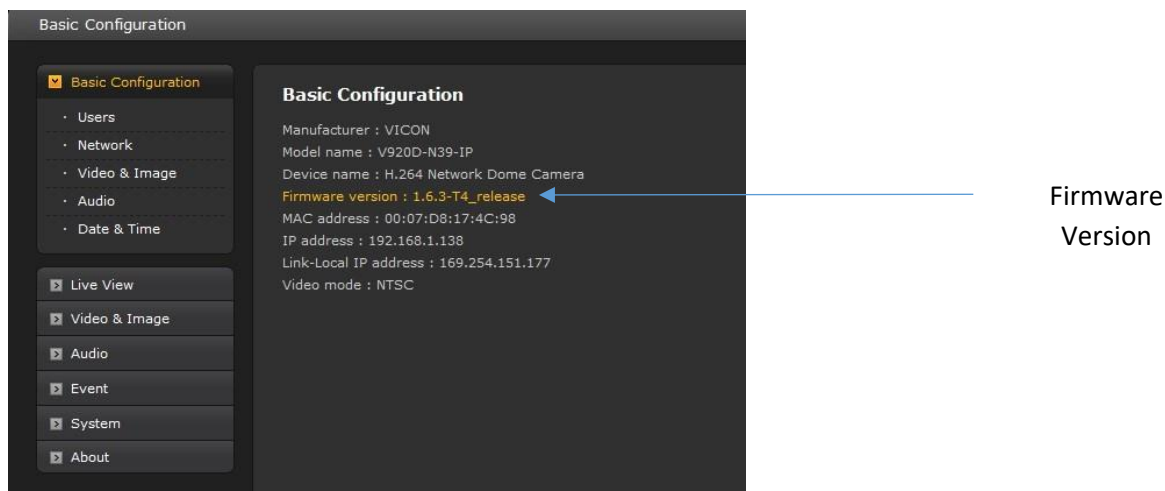
Once complete, the firmware version can be checked from the Basic Configuration screen.
