Release Notes

April 2022

Updated Firmware for V2020-WIR-360 and V2032-WIR-360 Multi-Sensor Cameras

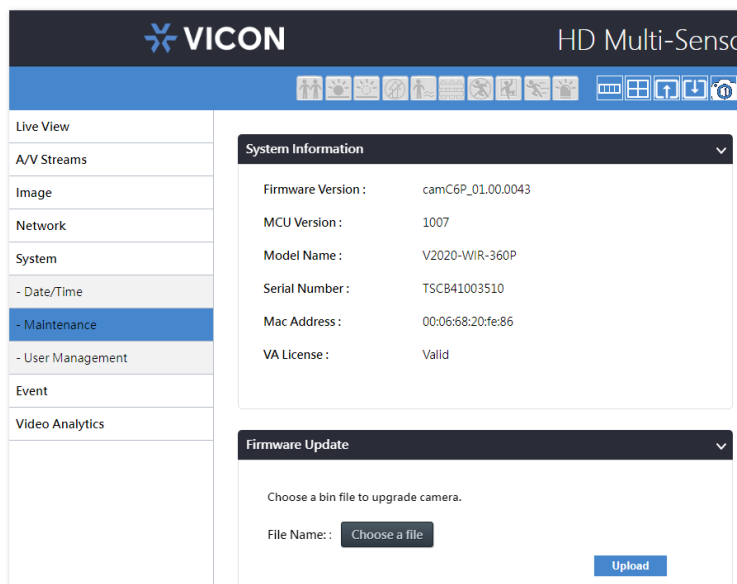
Download the firmware to your PC. Go to the camera’s Maintenance screen. Click “Choose a file” to point to the new firmware file and select “Upload”:

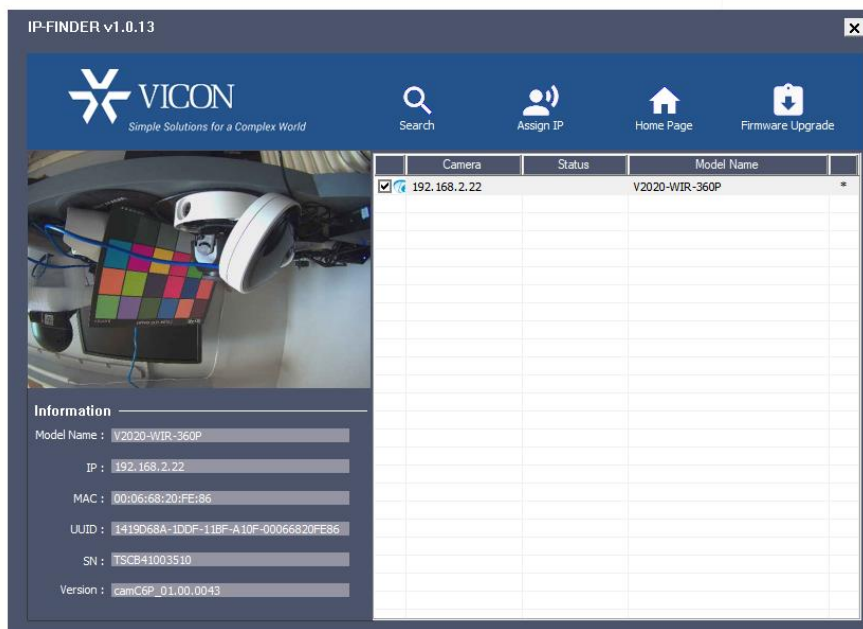
Alternatively, the Vicon IP Finder utility allows updating multiple cameras at the same time:
